# **Foamed Bitumen Stabilisation in New Zealand**

## **– A Performance Review and Lessons Learnt**

**Allen Browne**

*Hiway Stabilizers New Zealand Ltd*

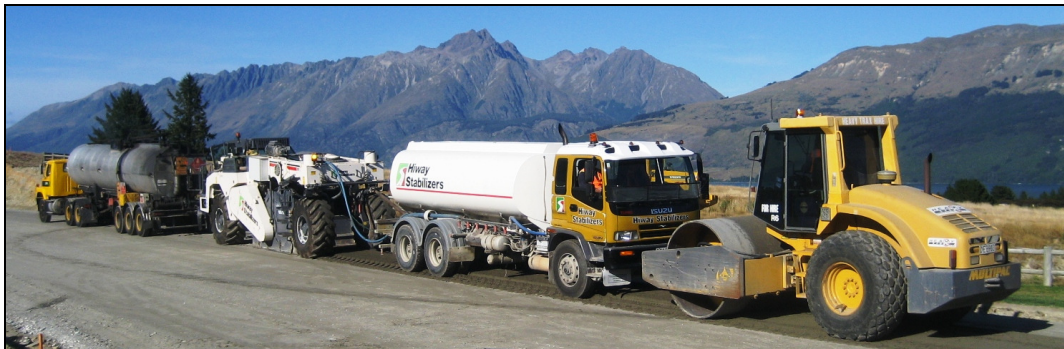
*FBS 'train' operating in Queenstown illustrating from left to right bitumen tanker, WR2000 purpose-built hoe, water tanker and primary steel drum compaction plant.*

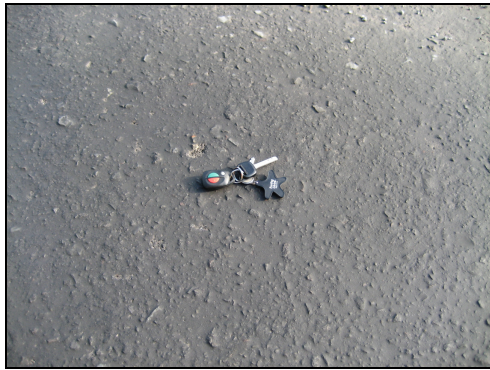
*Common FBS surface finish*

There have been a number of surfacing issues realised and addressed over the last several years. The FBS process results in a finished surface that does not present the conventional “stone mosaic” finish as referenced in TNZ B/2. The finished surface at sealing stage is very hard, but can be relatively smooth and ‘fatty’ - providing a low texture. It is essential to maintain a slightly moist surface and undertake robust brooming.

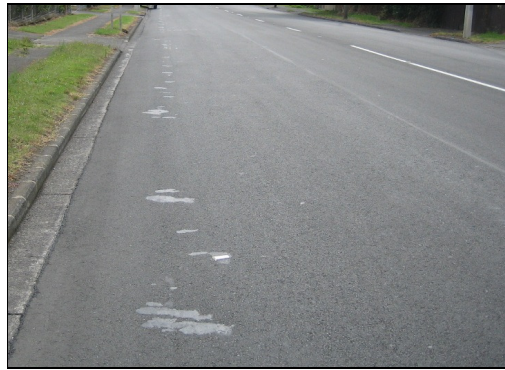
*Membrane seal ‘bleeding’ through thin asphalt surfacing. Note line of ‘blooms’*

The surfacing of FBS basecourse for some early contracts presented flushing issues for seal coats. In addition to this, several sites presented problems related to binder rich membrane seals ‘flooding’ thin asphalt surfacing to the extent that instability developed in high stress areas. Seal design and surfacing needs to represent the unique nature of FBS basecourse.

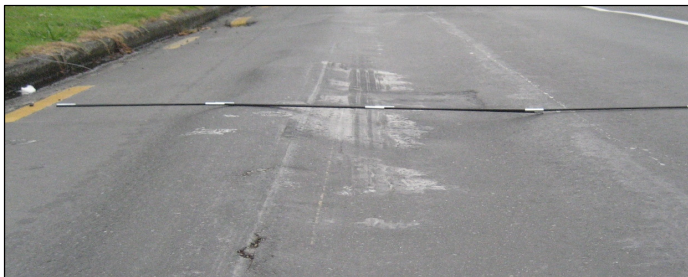
*This picture shows rutting/shoving and an unstable asphalt surfacing in a high stress braking area. An investigation was undertaken to confirm causes.*

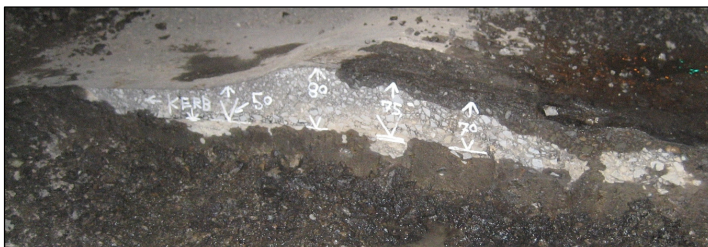
*Trenching by the Client confirmed relief was entirely in membrane / asphalt surfacing with a level FBR surface*

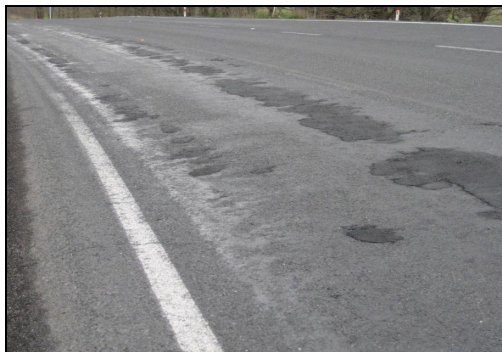
*June '07 Primary wheel track repairs*

Hiways were the FBS subcontractors for a contract on SH1, Taupo that was surfaced in mid-June. The chip stripped from the emulsion seal coat and the seal coat was lost from much of the wheel tracks on the night after surfacing. Inclement weather and cold conditions did not permit immediate remediation. A variety of temporary measures were adopted to 'hold' the site until a robust surfacing repair could be undertaken in approximately 4 months time. Despite the use of intermittent wheeltrack seal coats and asphalt maintenance repairs employed during winter, much of the FBS basecourse surface in the wheeltracks was exposed to traffic for extended periods.

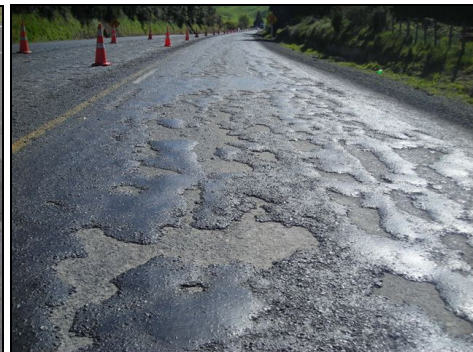
*October '07 major surfacing failure*

The first period of sustained hot weather in October resulted in a major seal failure. The entire surfacing through the section mobilised and a very rough surface quickly developed exposing large tracts of the FBS basecourse which appeared to have maintained shape and surface finish. After consultation the entire surfacing through the site was graded away and the FBS surface evaluated, and found to be in adequate condition for resurfacing with no structural repair required.

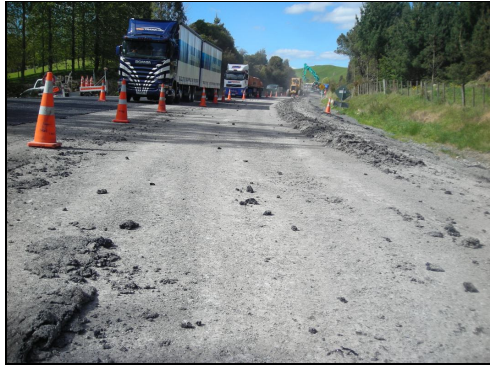
*Removal of all seal*

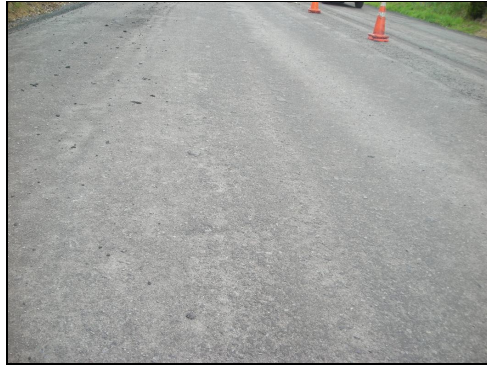
*Exposed FBS basecourse prior to reseal*

A new 2-coat seal was undertaken successfully with hot straight run bitumen. It is a testament to the unique properties of the FBS basecourse that it survived the environment and stresses through the winter period without failure.

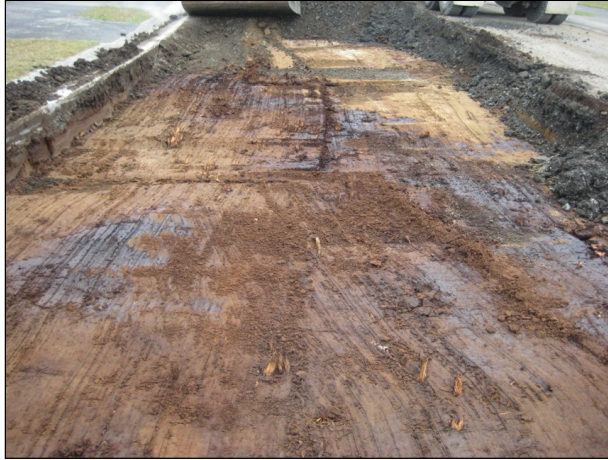
*This picture illustrates the high level of subgrade variability. Soils range from the pale brown non cohesive silty fine sand with very minor organics to dark brown organic silty clay / black highly organic silty clay.*

*Test pit samples that the FBS mix design testing was undertaken on comprised the pale brown silty fine sand.*

Unfortunately the deflection testing and 9 x test pits for the 3,200m<sup>2</sup> area did not reveal that a significant portion of the site subgrade comprised an organic silty clay/clayey silt.

Two elements that raise 'alarm bells' for any aggregate stabilisation project are where cohesive soils or organic materials may be incorporated into the treatment depth. Here both of these 'undesirable elements' were present but not identified through parts of the site and by the time FBS was suspended, a significant portion of the site had been treated.

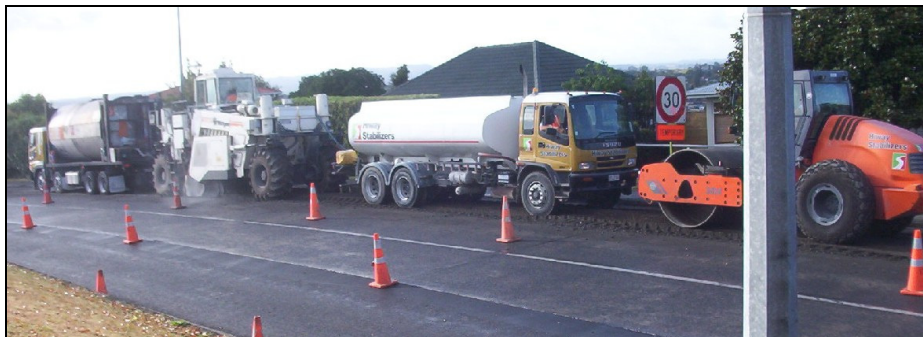
*FBS in urban setting with an existing central concrete strip that was retained.*
